**TEST REPORT ON INFRARED
WARNING RECEIVER (IRWR) FLIGHT
VIBRATION MEASUREMENTS**

REPORT NO: AFWAL/FIBG/79-10

TYPE OF TEST: Airborne Vibration Measurements

This test report presents data which define the vibration environments experienced by two infrared warning receiver (IRWR) units mounted on the HH-53 helicopter and the C-130E transport aircraft.

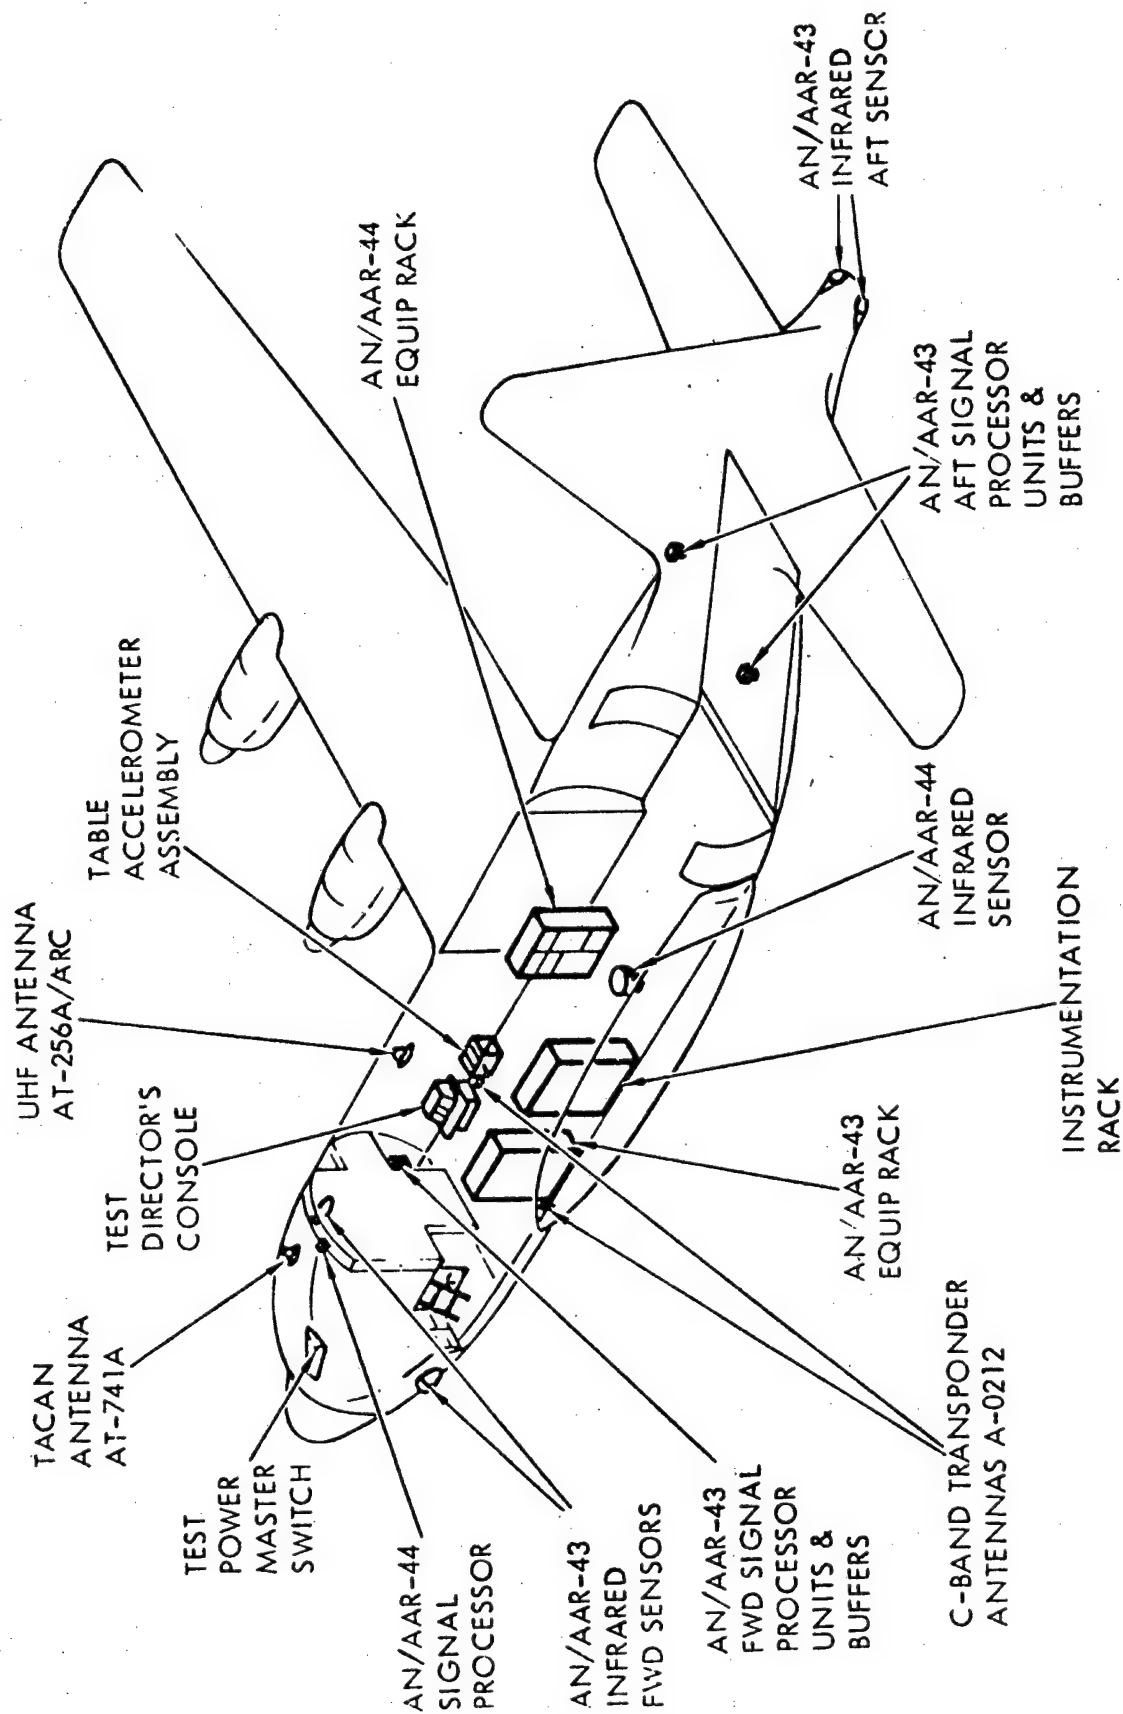
Figure 1. C-130E Installation.

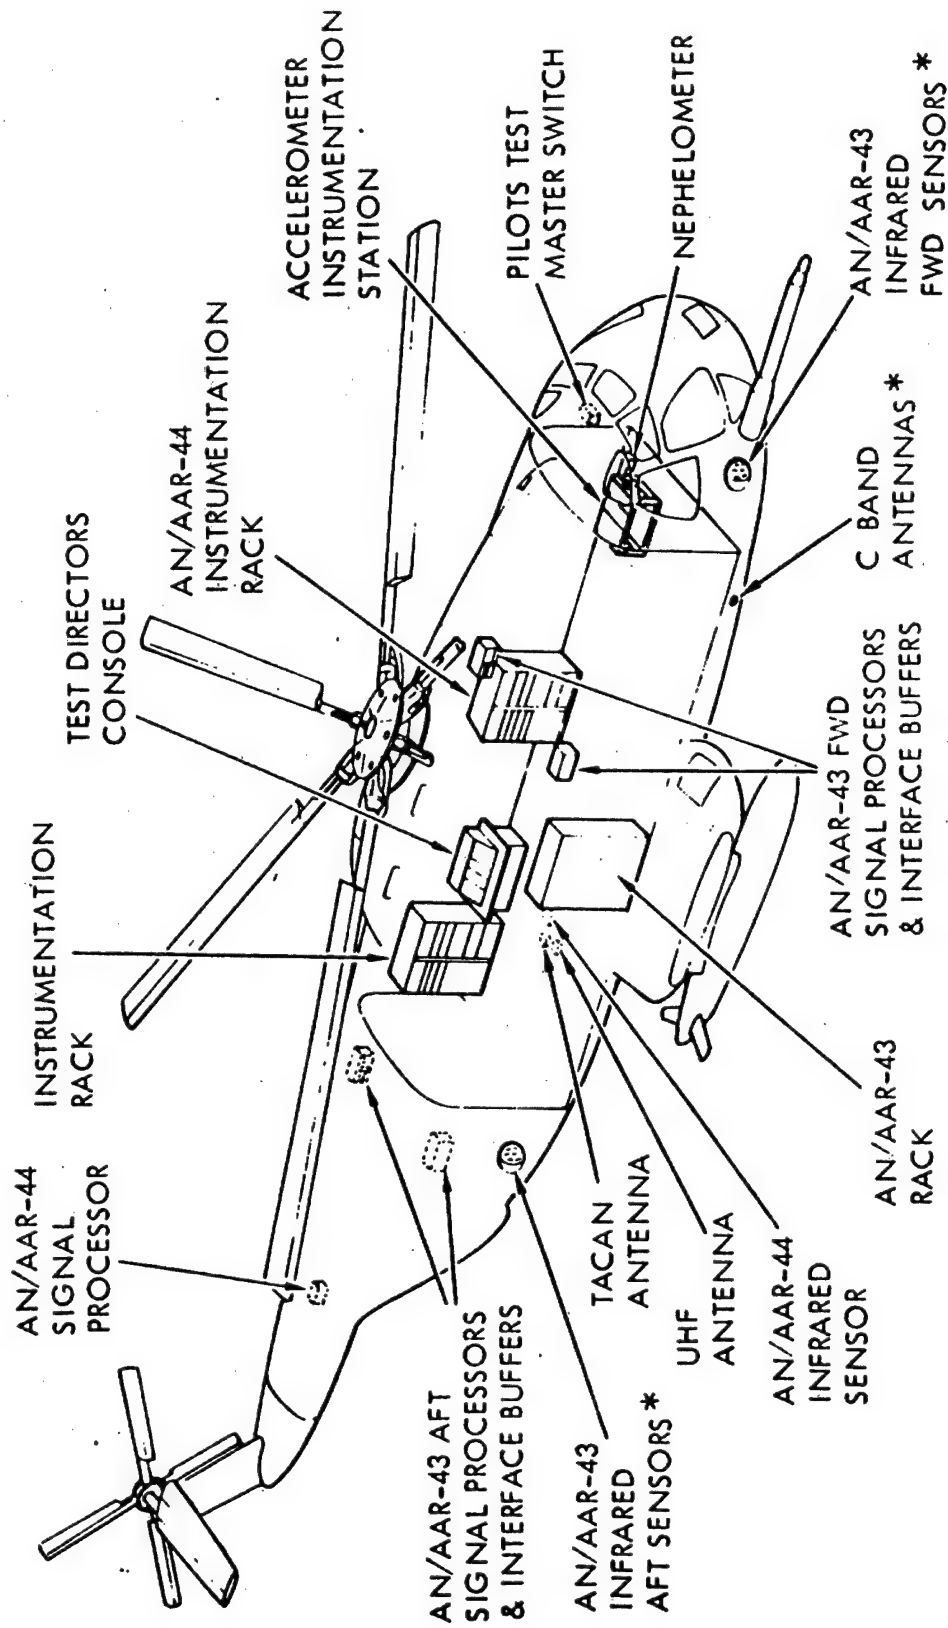
Figure 2. HH-53C Installation.

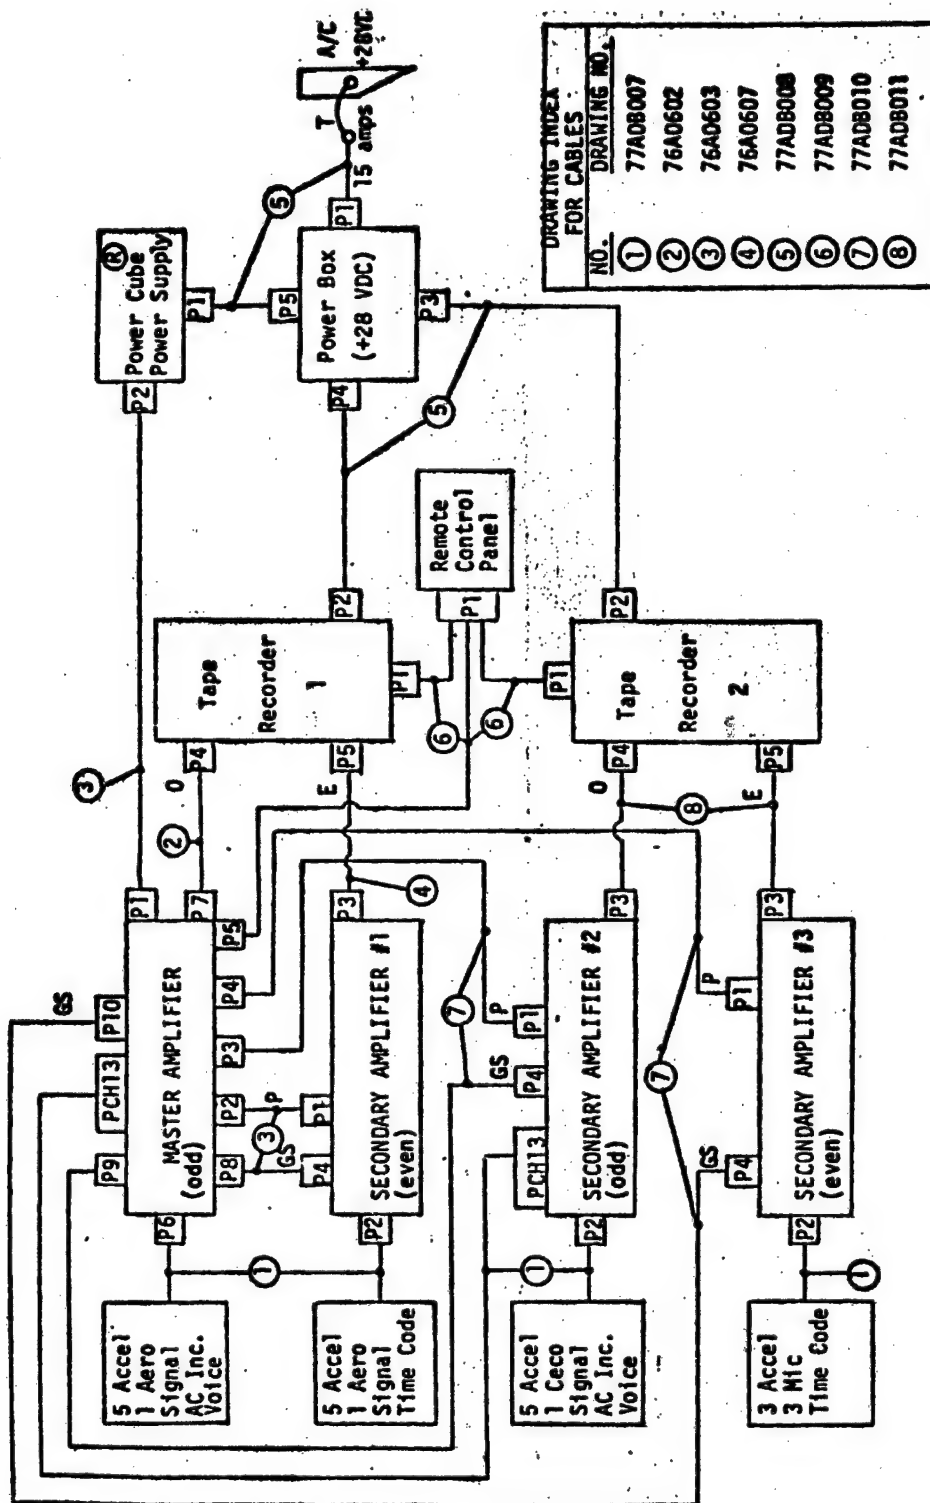
Figure 3. Vibration Instrumentation Block Diagram.

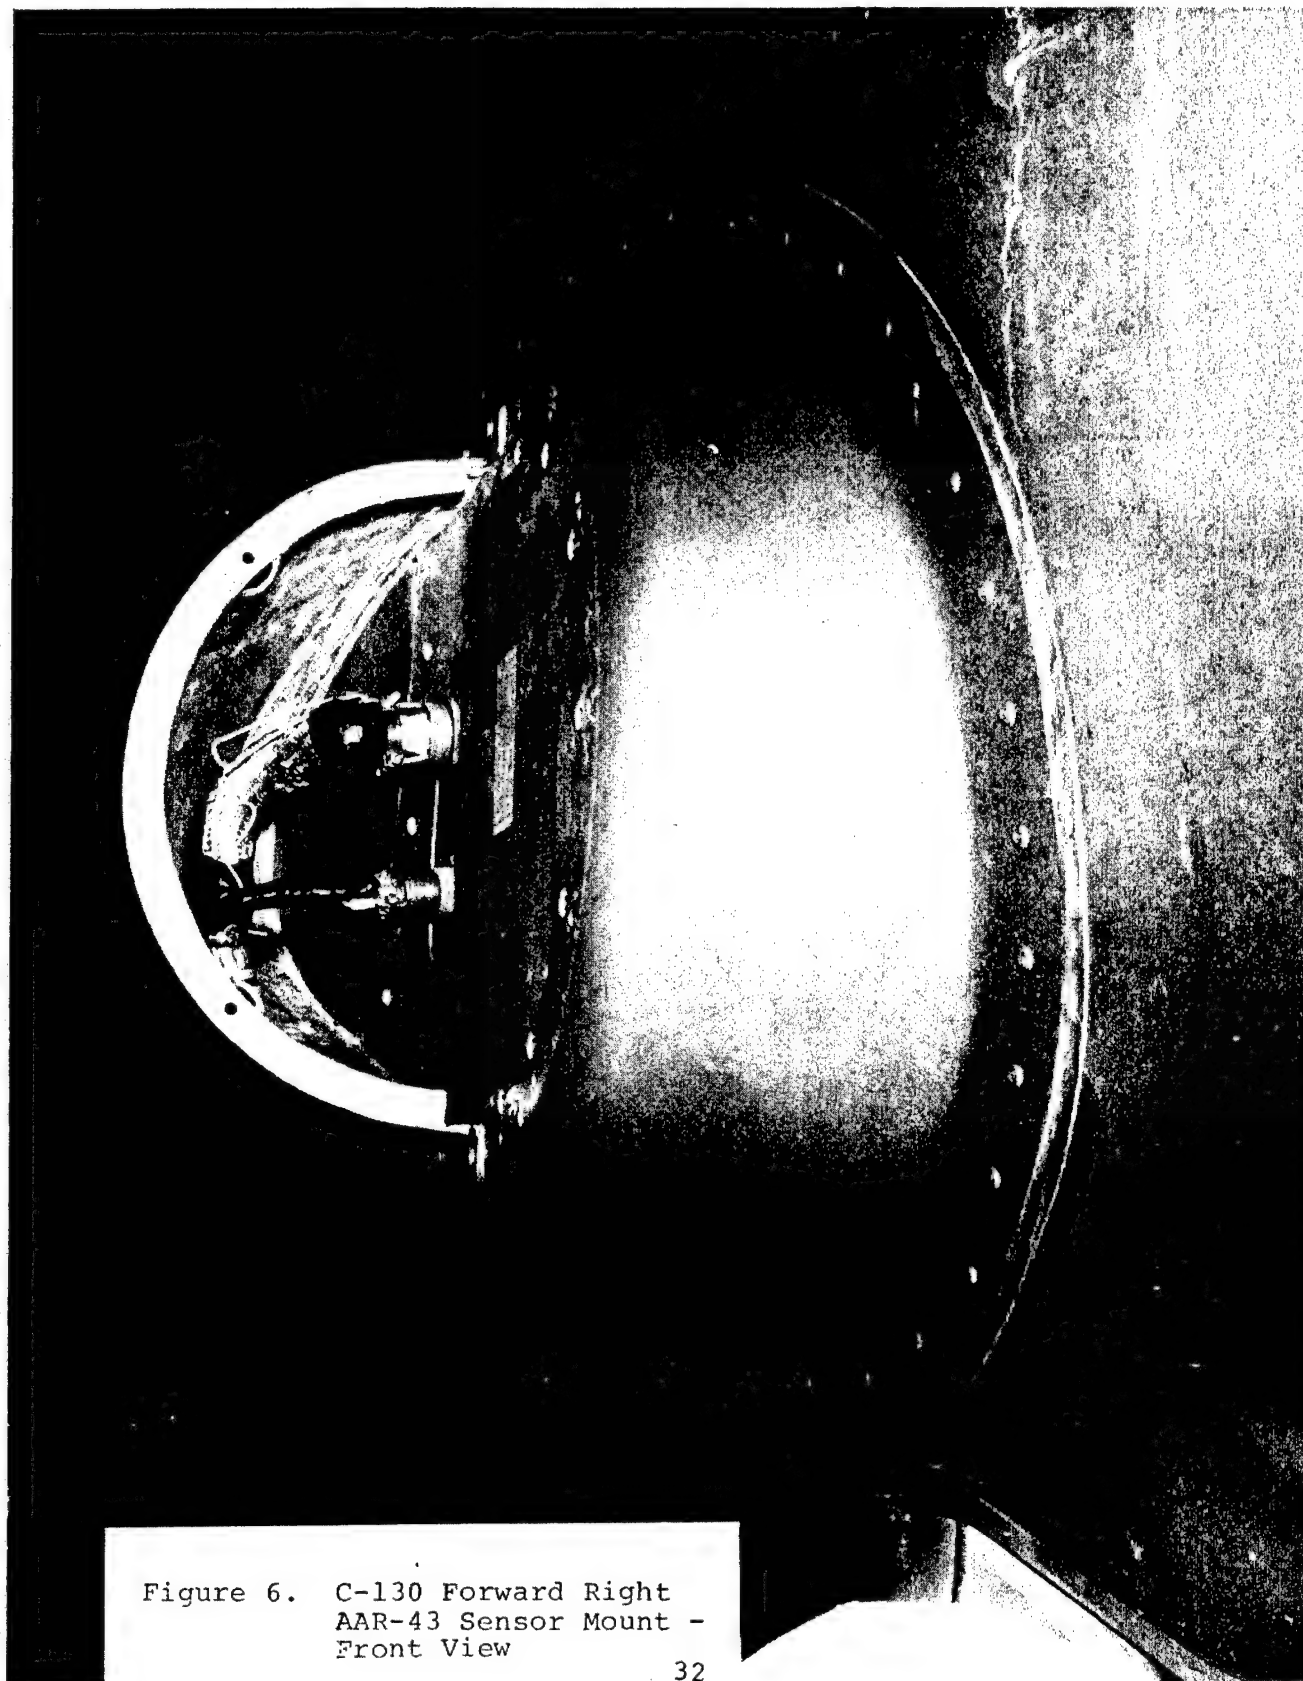
Figure 6. C-130 Forward Right
AAR-43 Sensor Mount -
Front View

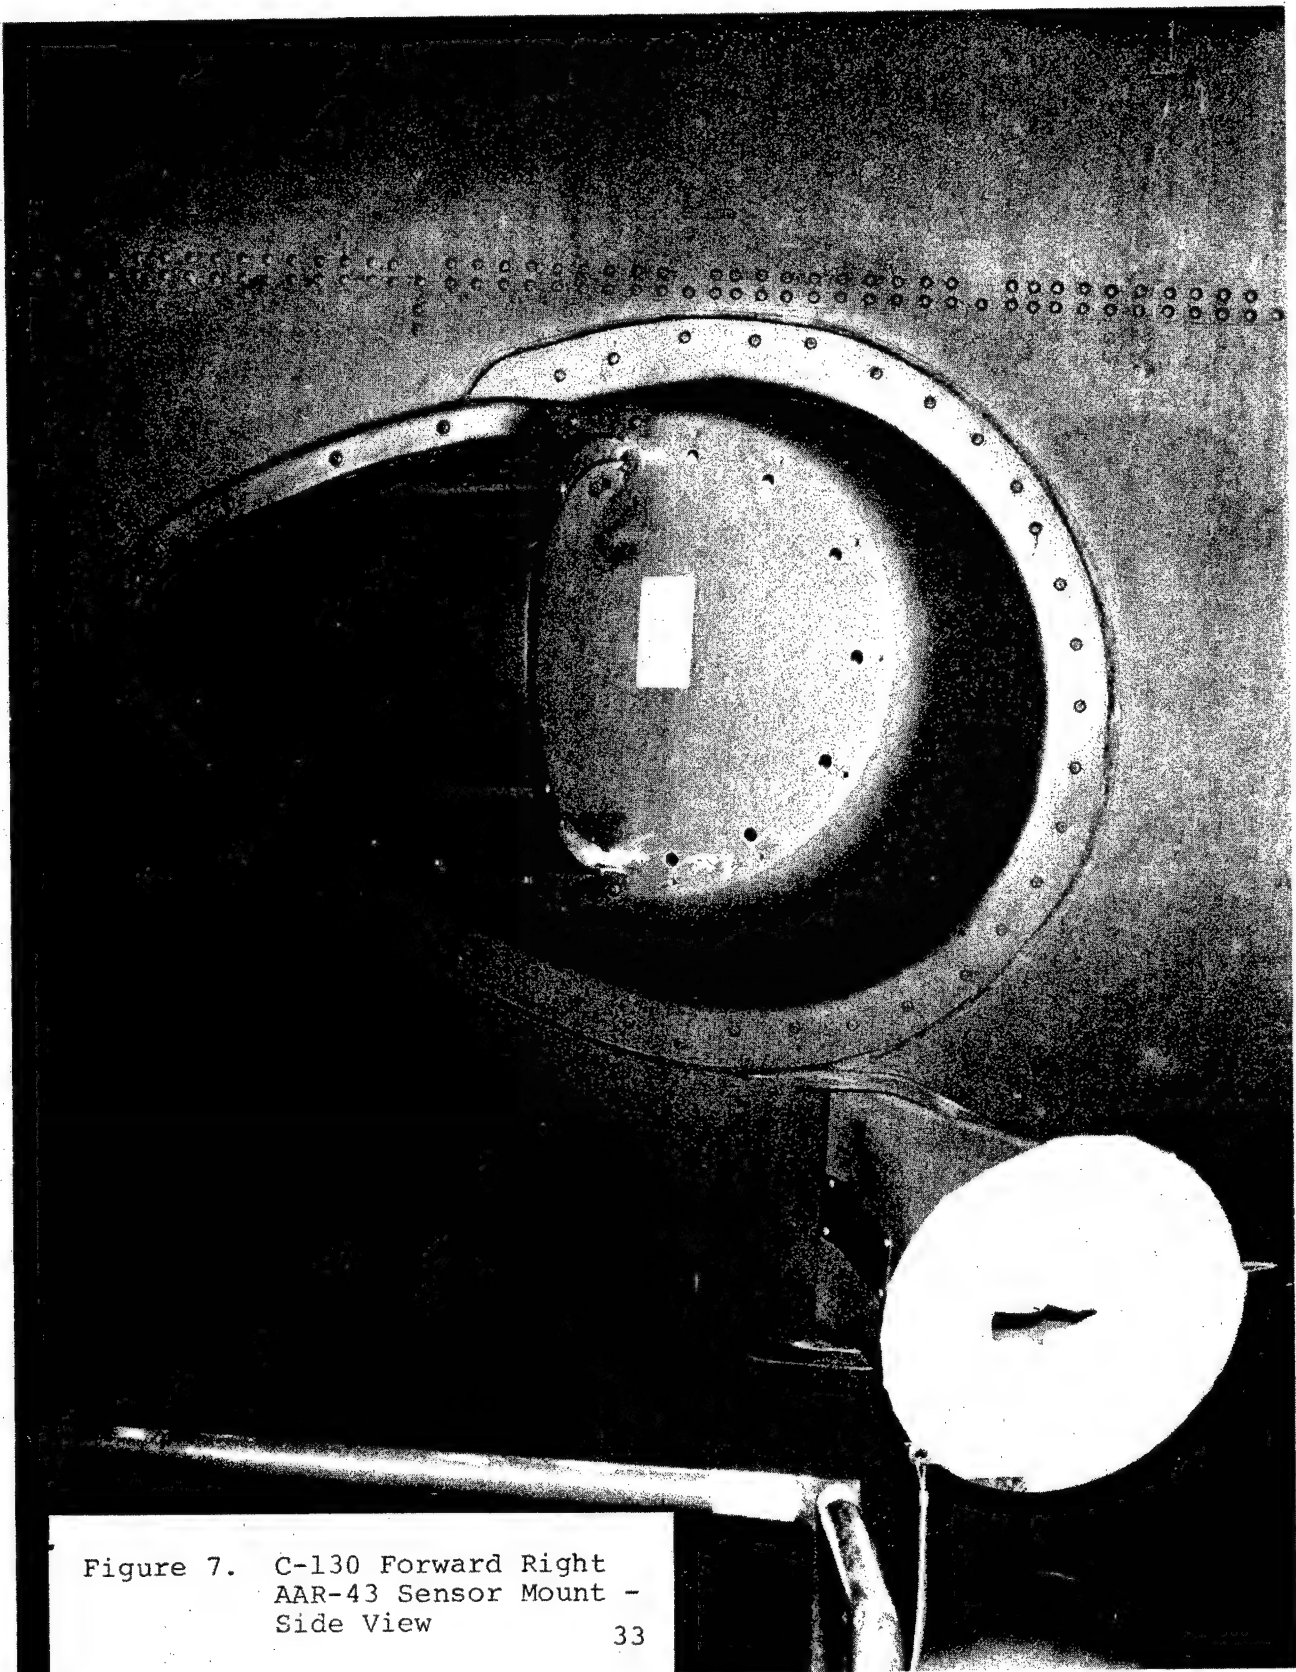
Figure 7. C-130 Forward Right
AAR-43 Sensor Mount -
Side View

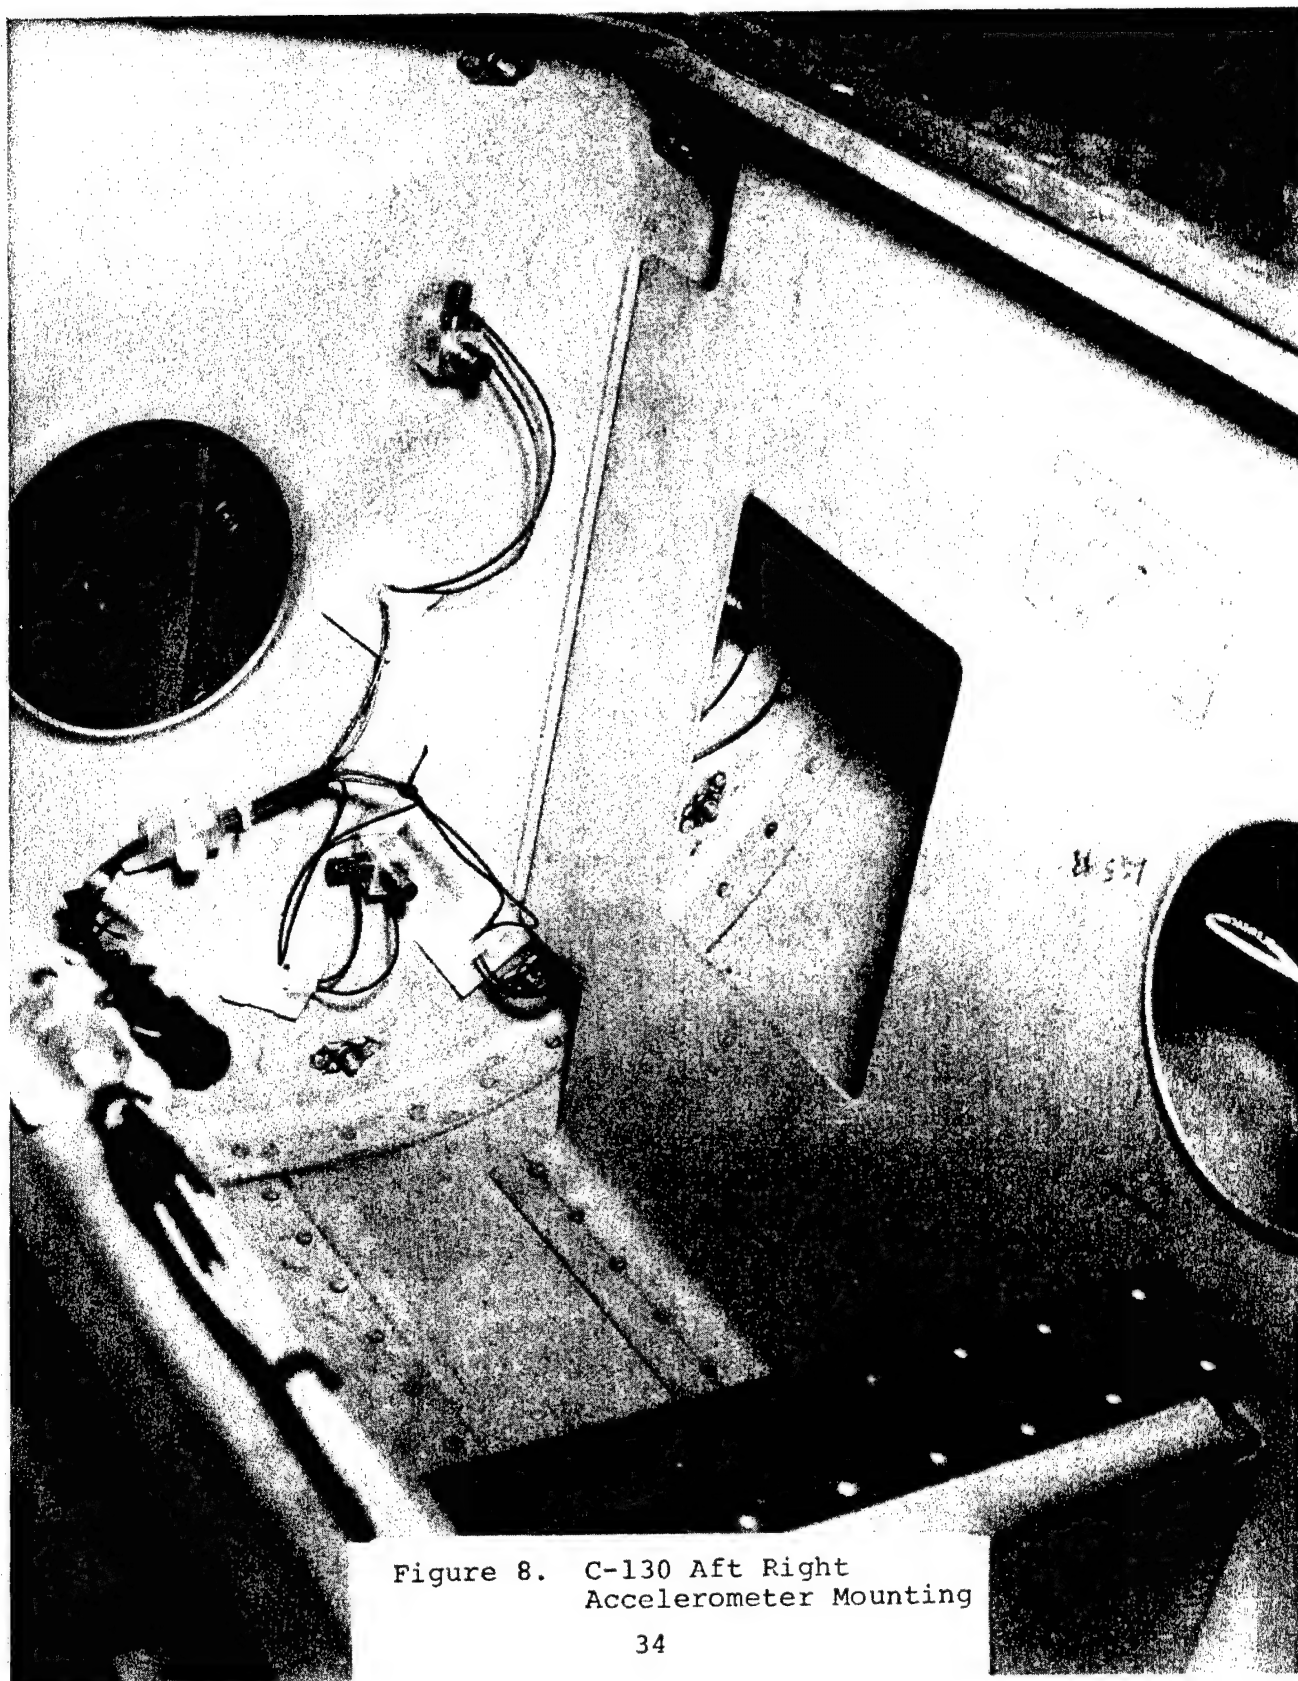
Figure 8. C-130 Aft Right
Accelerometer Mounting

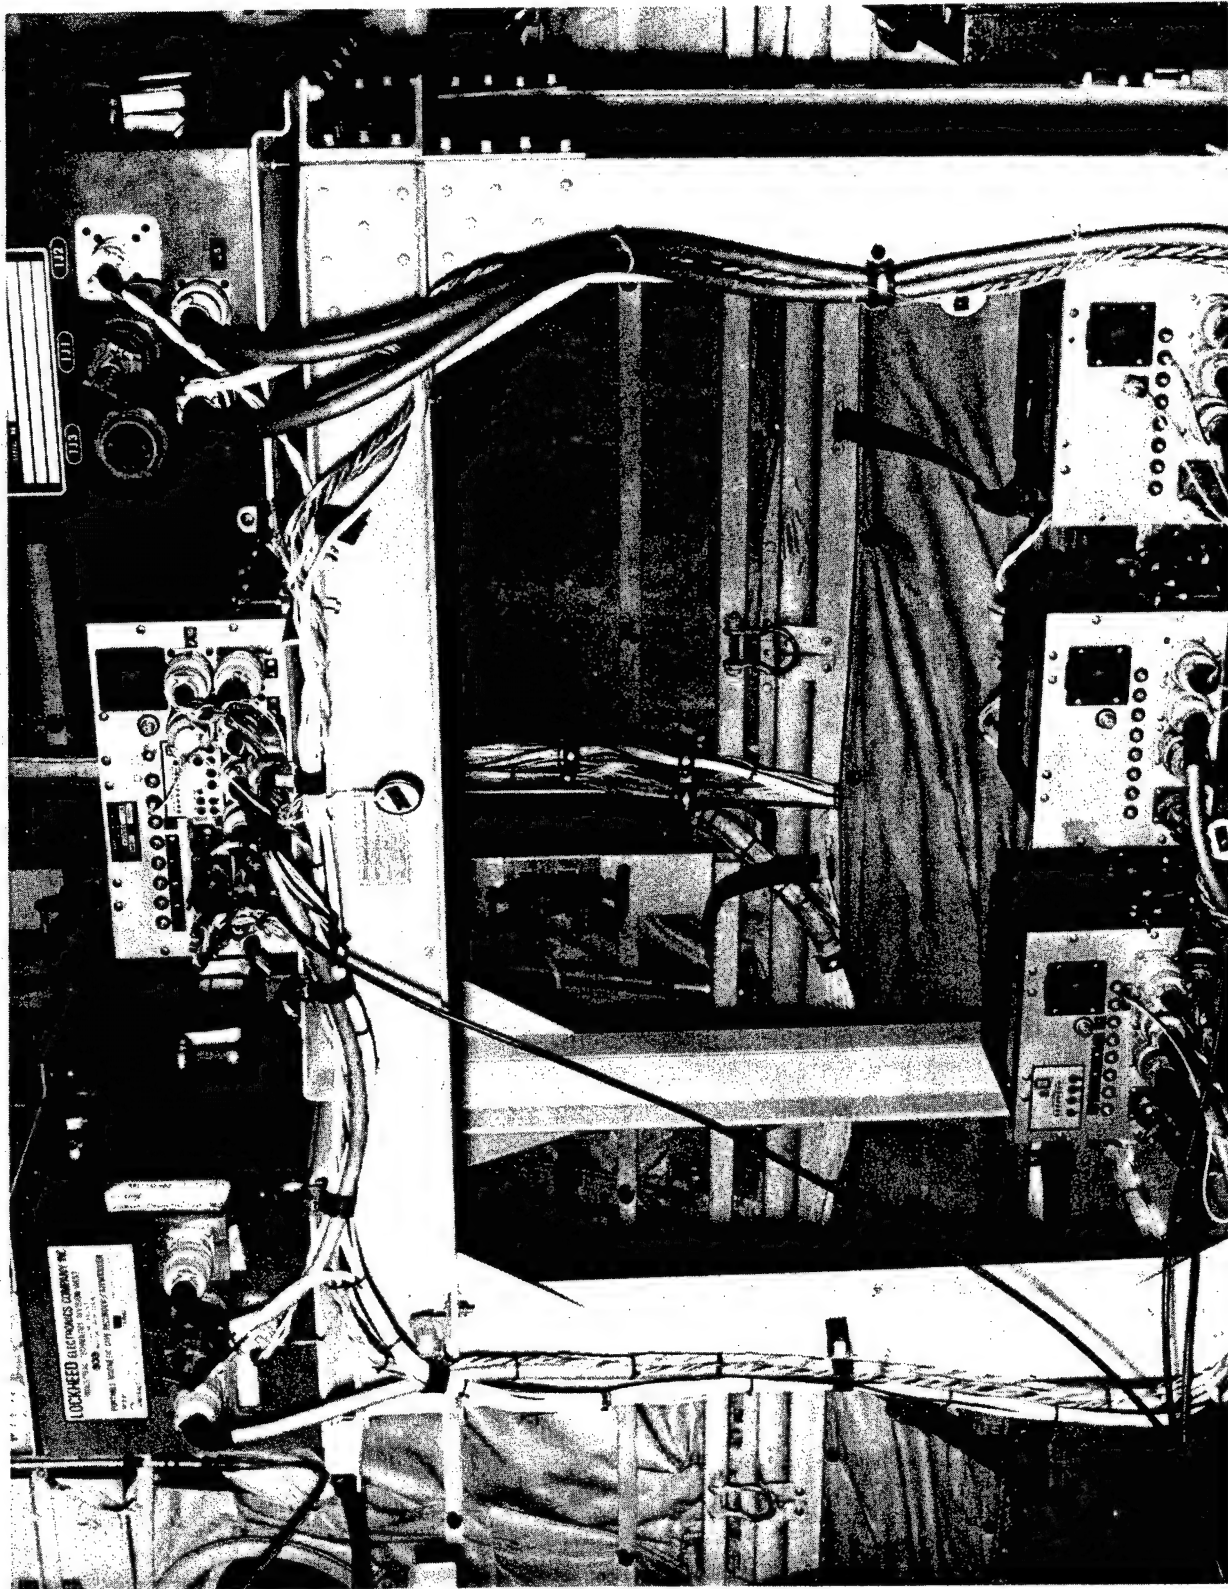
Figure 9. Wheaton Table and Electronics

The four amplifier systems, two tape recorders, power supplies, and power distribution box were mounted on a Wheaton table by 4950th TW personnel as shown in Figure 9. The table, including equipment and cables on it, was moved from one aircraft to the other as required by the test conditions. A separate remote control panel and its associated cables were installed in both aircraft, as shown in Figure 10. The four amplifier input signal cables and the aircraft power input cable were also installed in both aircraft. Thus, moving the instrumentation system on the Wheaton table required disconnecting and reconnecting the four amplifier input connectors, four remote control connectors, and the aircraft power input connector. The estimated weight of the Wheaton table plus equipment and cables was 196 pounds.

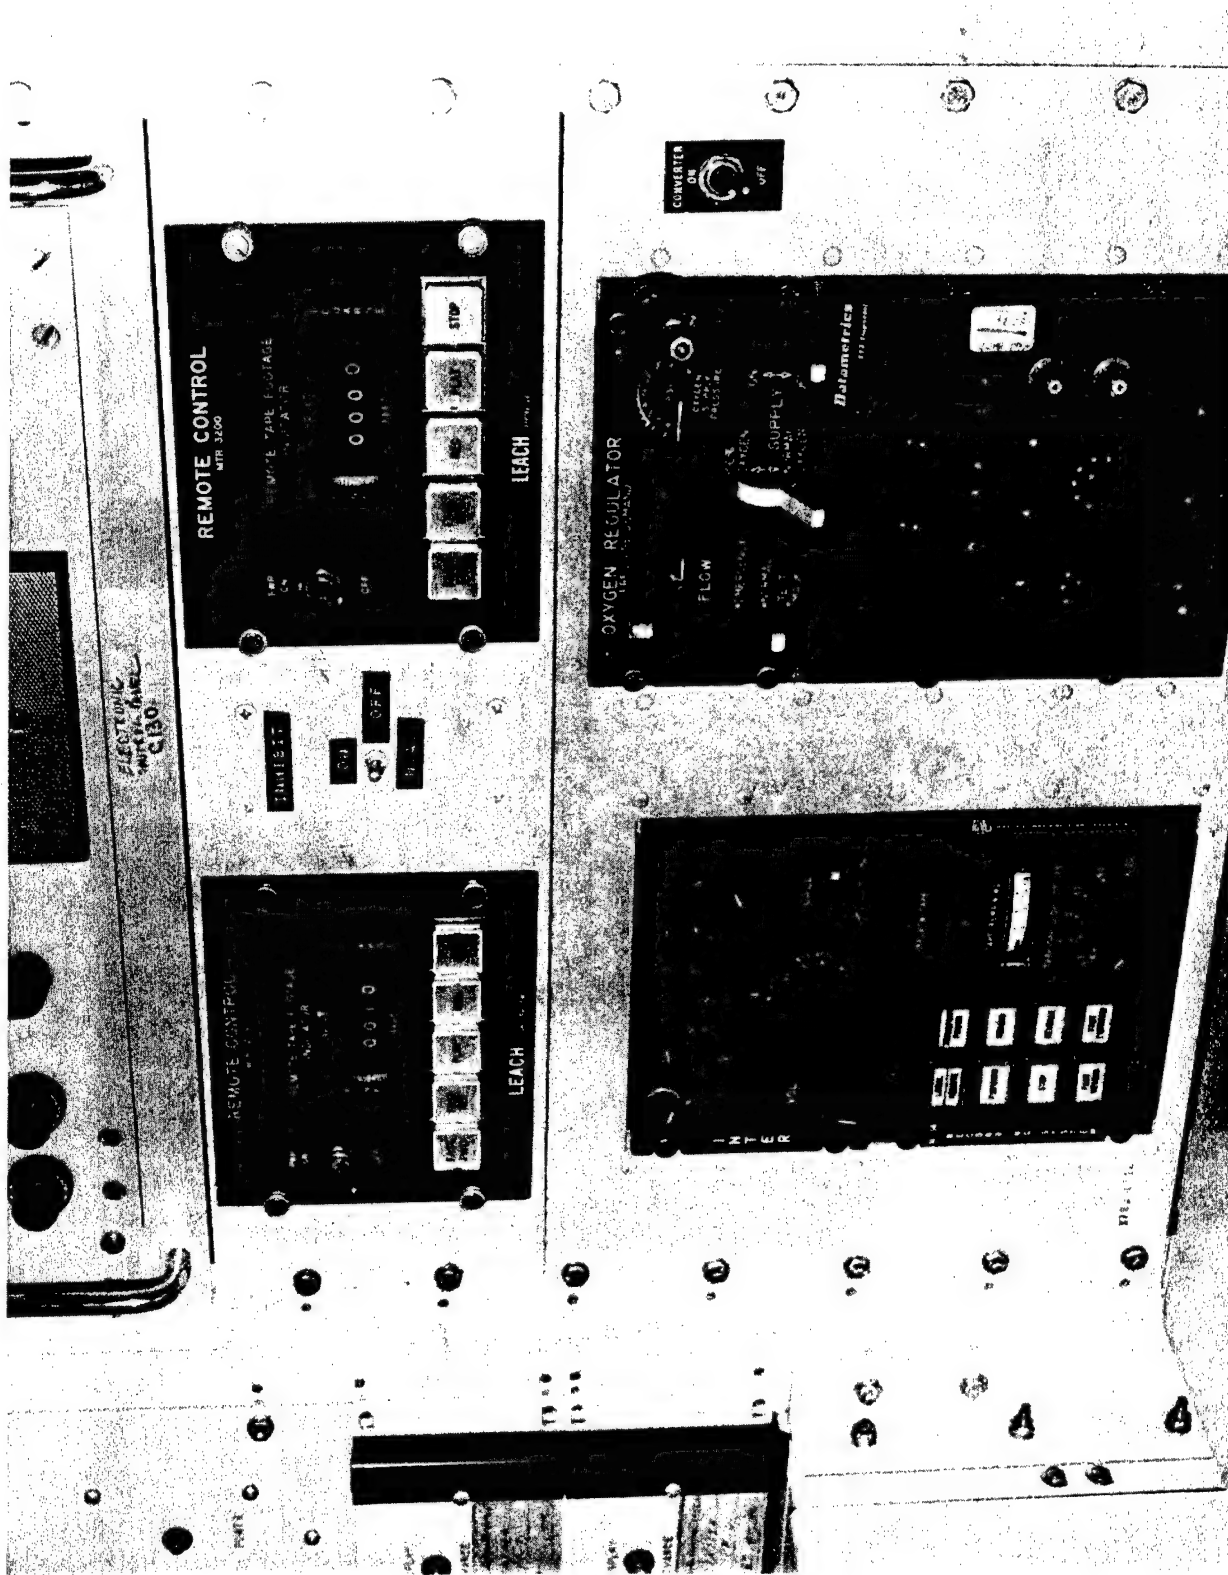
Figure 10. Remote Control Panel for Electronics

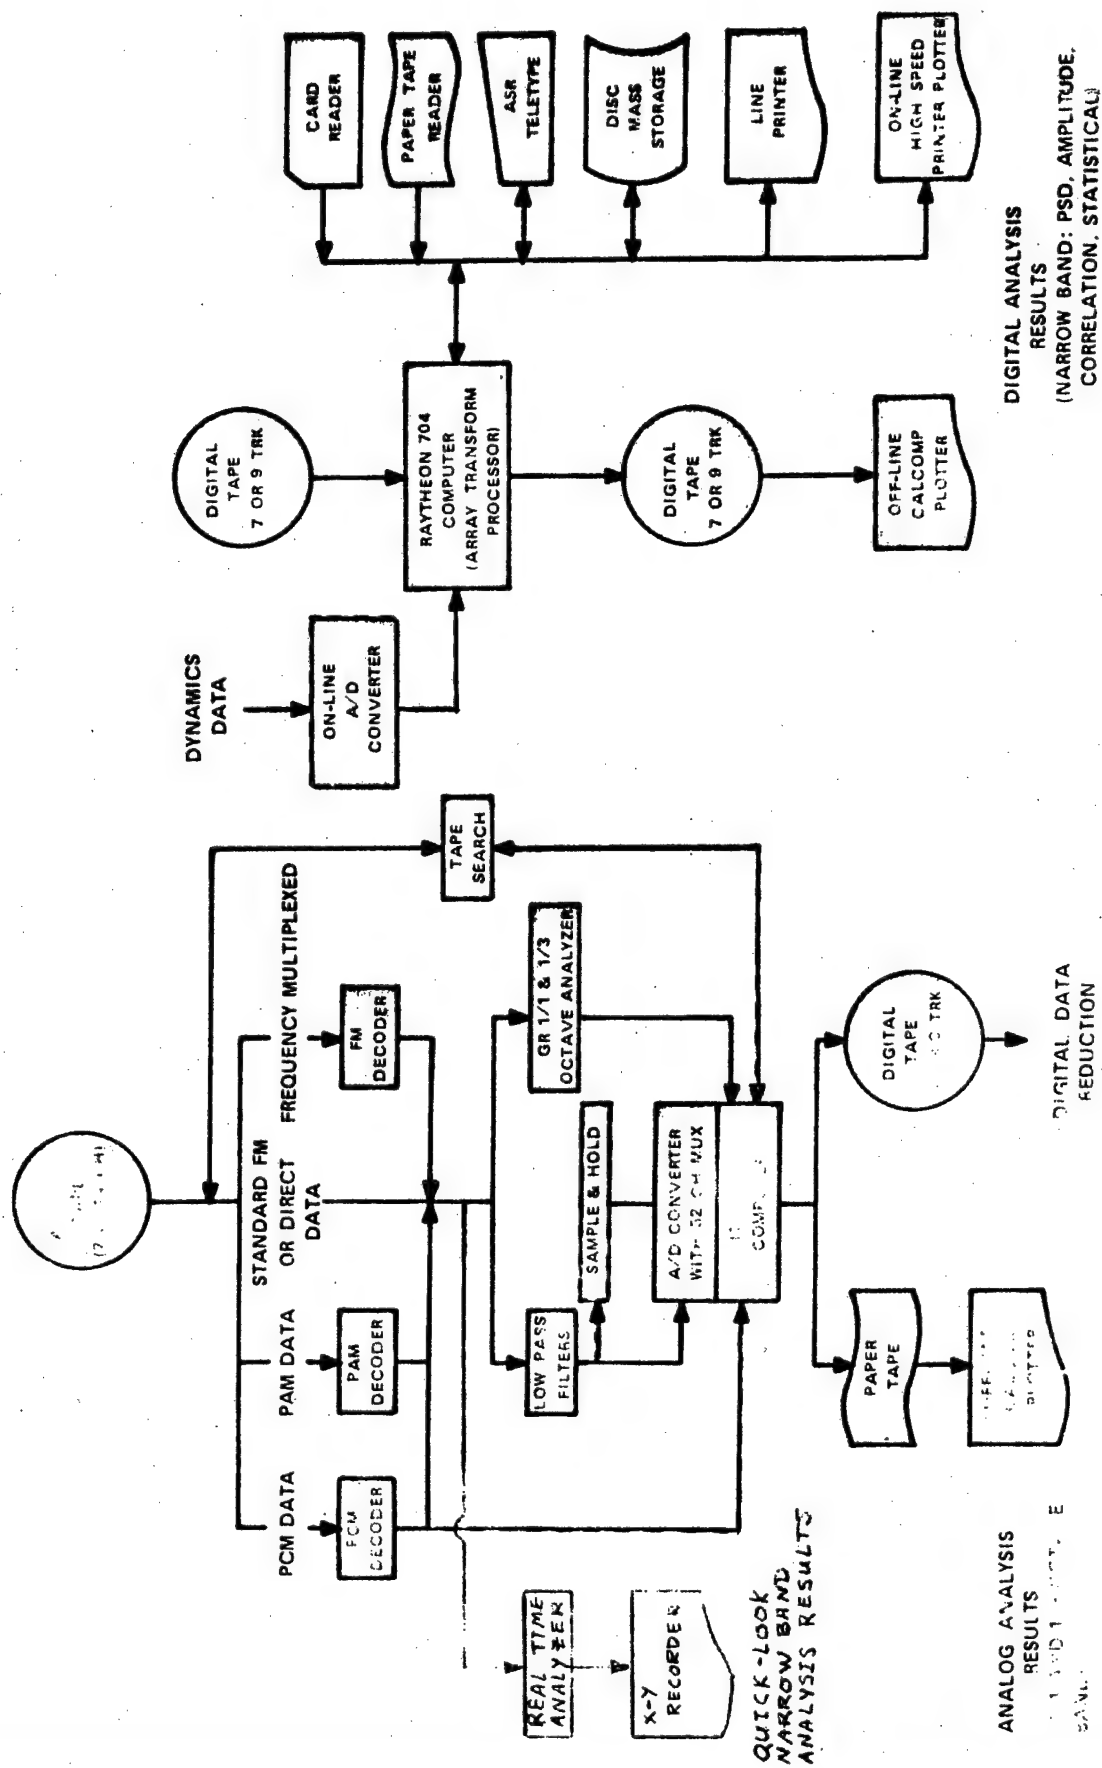
Figure 11. Flow Chart for Data Analysis
